Reconstruction of a Deteriorating, Tiered, MSE Wall Structure in Connecticut

RECONSTRUCTION OF A DETERIORATING, TIERED, MSE WALL STRUCTURE IN CONNECTICUT

Paper No. 3.25b

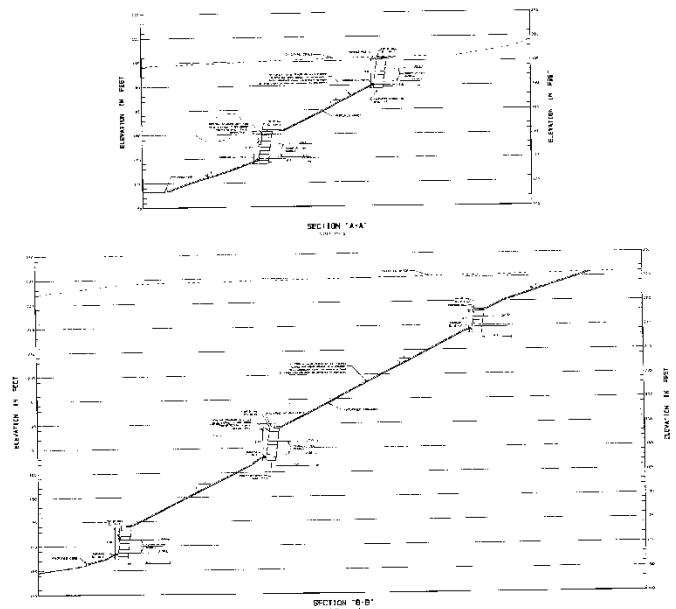
The original cut wall, which was constructed in the early 1990's consisted of a segmental retaining wall ranging from one to three tiers in combination with slopes between tiers; see Figure 2. To provide transitions from the building and perimeter access roadways along three sides of the proposed structure, a single, double and triple tiered MSE wall system in combination with 2H:1V slopes between tiers was utilized. The MSE wall was reinforced with uniaxial geogrid and biaxial geogrids. The uniaxial geogrids were typically equal to the wall height and positioned at spacings of approximately two to three feet vertically. The biaxials geogrids were four feet long and positioned between and above the uniaxial geogrid.

Figure 2 – Original Segmental Retaining Wall Cross-Section

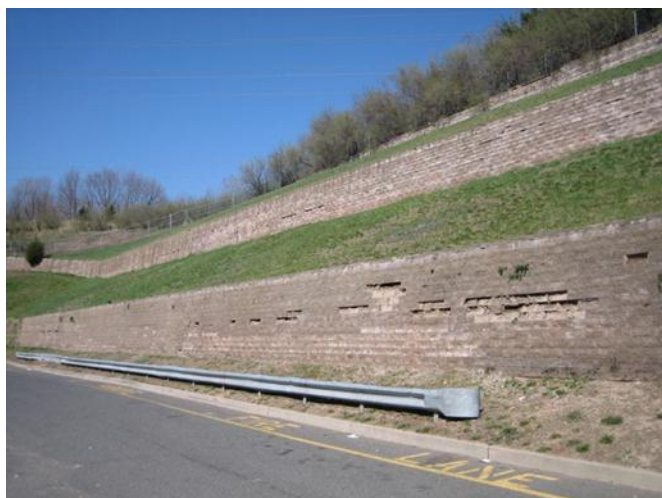
Due to the lack of available information regarding the freeze-thaw effects on the modular block facing at the time of construction, the impact of this behavior was not properly considered in the original design. Consequently, less than 20 years later, freeze-thaw effects deteriorated the majority of the facing to the point where the overall stability of the wall was in question. Specifically, facing block failure was leading to localized raveling of soils and creating erosion zones at the face of the wall. If left unchecked, these areas of erosion would have continued to extend deeper into the slope, compromising the integrity of the MSE structures, and thereby the overall slope.

In 2003, approximately 10-years after completion of installation, significant deterioration of the facing of the modular block system was documented with further deterioration being documented between 2003 and 2007. In 2004, studies were completed to determine the mechanisms of deterioration and potential causes for the significant reduction in design life of the modular block system. The conclusions of these studies indicated that the modular blocks utilized were susceptible to freeze thaw cycles and mitigation would be required in the future. The details regarding the material components, specific manufactured block makeup and causations of the reduced design life are beyond the scope of this paper. In 2007, the level of deterioration of the facing had progressed to a point where the stability of the retained soil and slope would become a concern at some point in the future; see Figure 3. In 2007, a design effort was undertaken to evaluate potential mitigation techniques in combination with continual observation/assessments of the condition of the walls and slopes relative to the need to provide immediate mitigation should a condition develop which would jeopardize the stability of the slope and the operations of the existing facility.

Figure 3: Typical Deteriorated Conditions

Following several iterations of the various design concepts outlined above, discussions with the owner, and pricing exercises with the Contractor, the decision to go with a tiered reconstruction of the existing walls was made. Specifically, a concept which incorporated the construction of new, large-block Stone Strong gravity wall in front of the existing lower and middle-tier walls combined with significant grading improvements over much of the upper slope was chosen. A cross-section of the chosen alternative is shown in Figure 4.

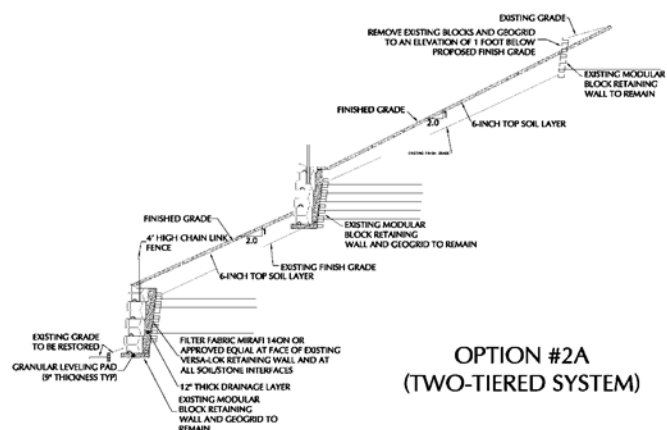
Figure 4: Typical Cross Section of Chosen Alternative

Perhaps the most important consideration, however, of the ultimately chosen design concept was the ability to incorporate the original construction into the final design, while at the same time, not overstressing the existing geogrid which was part of the existing wall. Specifically, just as standards and quality used in creating masonry blocks used in MSE wall construction has improved over the years, the strength, durability, and longevity of geogrid materials also continues to improve year by year. The grid that was used in the original wall construction, when compared to materials available today, was significantly less durable and had a considerably lower allowable tensile strength. As such, significant loading introduced above the existing walls as part of the new construction would most likely overstress the existing grid, leading to a failure in the lower tier of the wall. The chosen approach achieved a balance of minimal new load being introduced as part of the proposed grade modifications with the construction of an overall new retaining system.

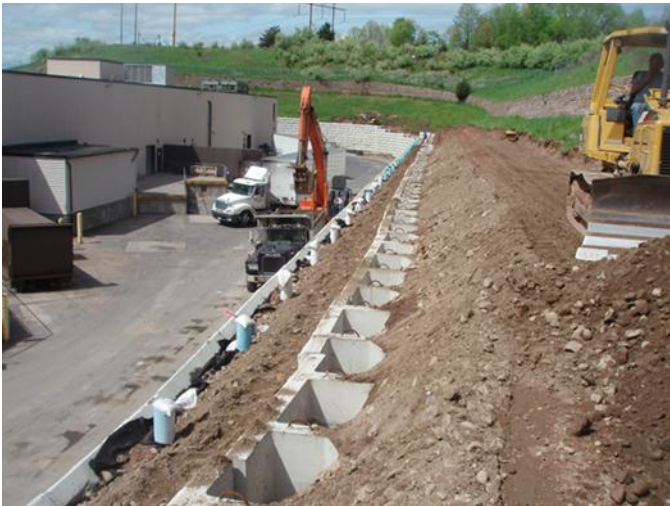
Figure 5 – Construction of the Temporary Roadway between Wall “A” and Wall “B”

As construction of the second tier wall restarted in April 2009, the first order of business was to construct a temporary access road in front of the second tier wall to provide access to the Contractor to construct wall “B”. The temporary road construction was started on the slope on the southern portion of the site and proceeded moving north. Grubbing and removing the topsoil from the slope was the first step for the construction of the temporary road. Using a relatively lightweight excavator, the Contractor proceeded to cut into the slope, allowing enough soil to remain in front of the existing second tier wall so its stability would not be jeopardized, while at the same time staying far enough away from the lower wall to avoid imposing excessive temporary surcharge loads. A photo of the temporary roadway construction is shown in Figure 5. Incidentally, this turned out to be one of the most critical aspects of construction-phase design. To verify that the temporary conditions during construction were safe, intermediate slope stability analyses were completed prior to the Contractor proceeding with the temporary roadway/bench.

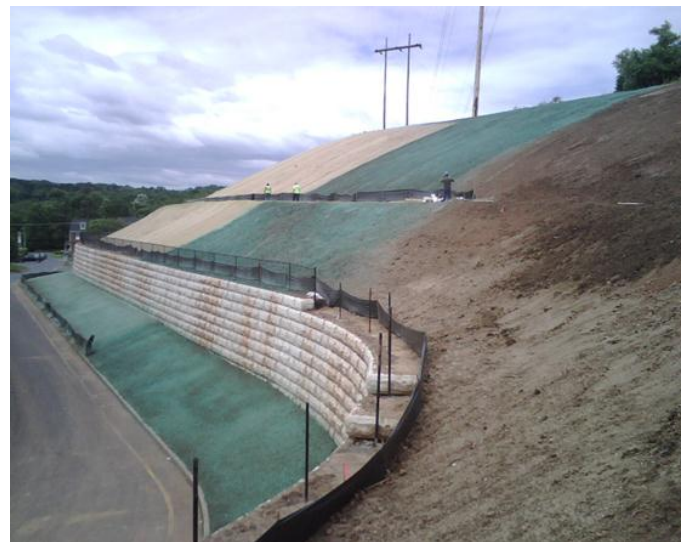
Figure 6 – Slope Stabilization Methods during Earthwork

Coincidental to wall “B” construction, the topsoil material on the slope starting in the northern portion of the site was grubbed and removed, and the existing third-tier retaining wall was partially demolished and hauled off-site. The exposed slopes were then regraded, generally to a slope on the order of 2H:1V. The slopes were established through the placement of compacted fill, similar to the criteria used to create the temporary road through the site. The grading work on the slopes then continued moving from north to south across the site. To provide a densified surface and stabilized slope face, the slopes were over-built and then cut back with a dozer, such that the firm, compacted soil slope was exposed at the design grades. Once the proposed grades were established, an erosion control blanket which was designed to facilitate vegetative growth on the face of the slope was then installed;

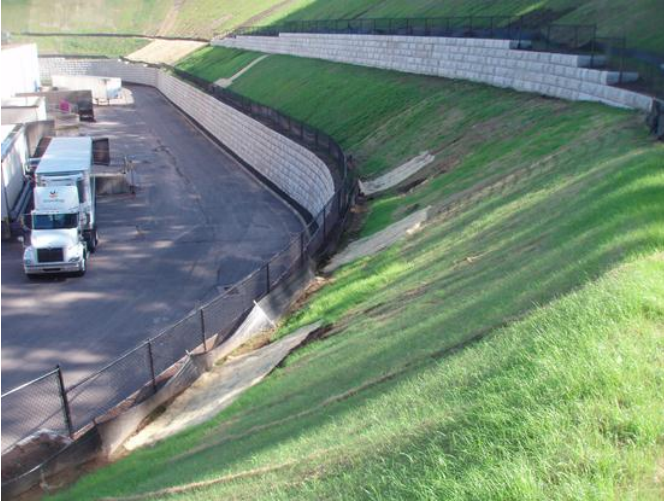
Figure 7 – Post-Construction Conditions

One challenge that was encountered during slope grading activities was that between the months of July and August 2009, several heavy rain storms passed through the Southington area, often in very short periods of time. Due to the fact that no vegetation had grown on the eastern and southern portion of the site at this time; the heavy rain storms had eroded several areas along the slopes. Luckily, access to these areas was still viable along the temporary roadway, and the Contractor proceeded to remediate these eroded areas using the on-site fill material. Hydroseeding and erosion blankets were then re-installed in the remediated areas. Construction of the retaining walls and slopes was completed in mid-August, 2009; see Figure 7.
